Naval Safety Command

SANITIZED SAFETY INVESTIGATION REPORT

DARKEN SHIP FATAL LADDER FALL

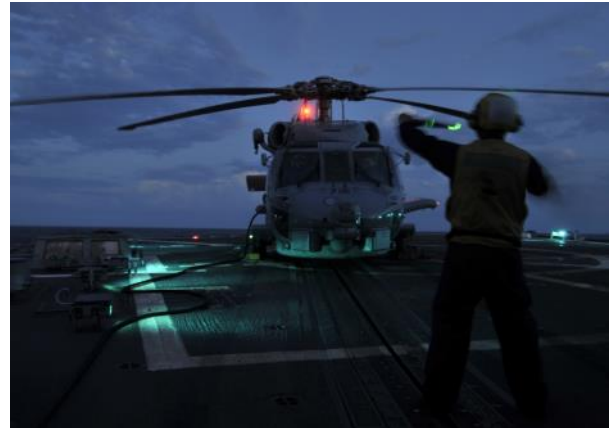
A ship had just completed a night-time flight quarters (FQ) and was independently steaming in waters in an overseas theater of operations. Upon securing from FQ, a Sailor and his supervisor departed from the flight deck, walking topside along an 0-2 level catwalk past the starboard boat deck to get to the 0-1 level. They intended to check Dog Zebra fittings and ensure proper rigging of a replenishment at sea (RAS) station for a scheduled RAS the following day. While they were together on the 02 level, the supervisor did not see the Sailor fall from the 02 level to the 01 level, but he heard the sound of a steel-toed boot hitting a knife-edge and noted the white FQ jersey the Sailor was wearing disappeared down the ladder well. The supervisor investigated and, finding the Sailor lying injured on the 01 level, he rushed to the closest available phone (integrated voice communication system – IVCS) in the wardroom to have the bridge call away a medical emergency. No IVCS was readily available at the mid-ship quarterdeck because the quarterdeck had been previously shifted to the fantail during a recent port visit.

4. Verify topside safety to include the following: Ensure proper installment and use of safety lanyards/chains topside; if permitted, illuminate dangerous trip hazards with tape/paint; ensure all ladder landings are clear of excessive gear (toolboxes, foreign objects); and install protective (rubber) guards/flashing on all sharp edges in the vicinity of hand bars above ladder wells.
